## Home Inspection Report

124 Street Ln, Indian Harbour Beach, FL 32937

Date of Inspection: 3/4/2019 Time: 2:00 PM

Inspector: Ryan Mayer

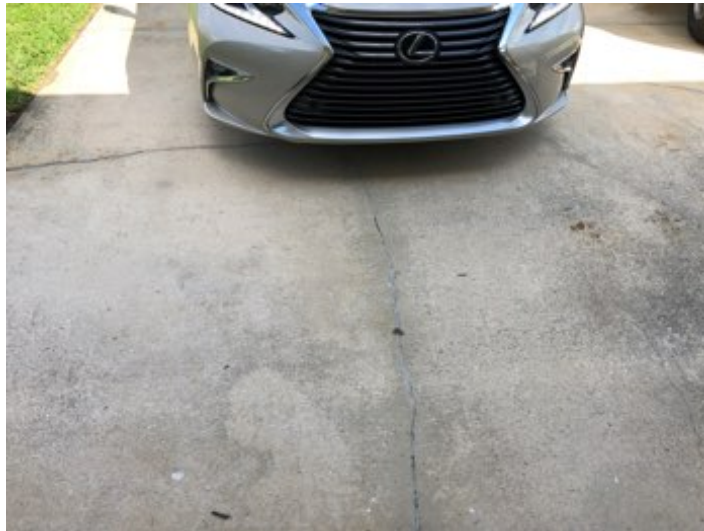
- Typical cracking was observed on concrete that may be due to shrinkage. Recommend sealing to prolong the life.

Minor Driveway Cracking

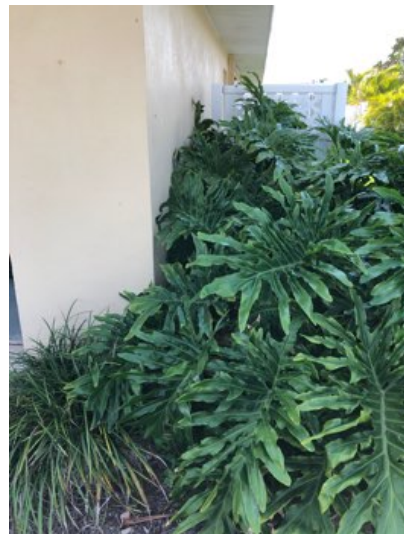
- Plants or bushes in contact with or close proximity to home should be trimmed to eliminate pathways for insects.

Vegetation on Siding

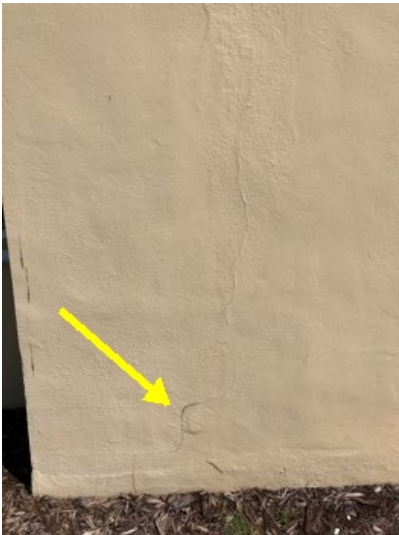
- The exterior stucco appears to be in satisfactory condition. Recommend annual monitoring for paint and sealing needs. There is evidence of previous stucco repairs. Minor settlement cracking of the stucco is evident on the west side of the structure. This is a minor defect. Recommend monitoring.

Cracking Along Block Joints

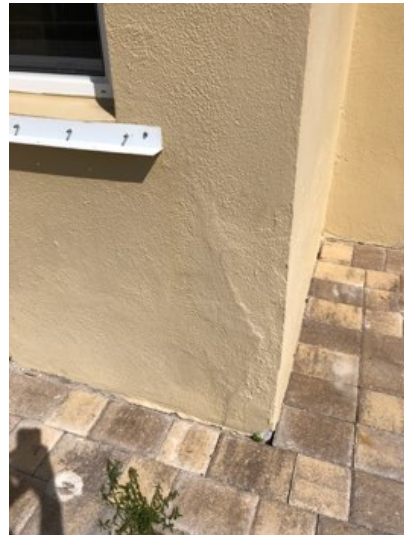
Previous Repair

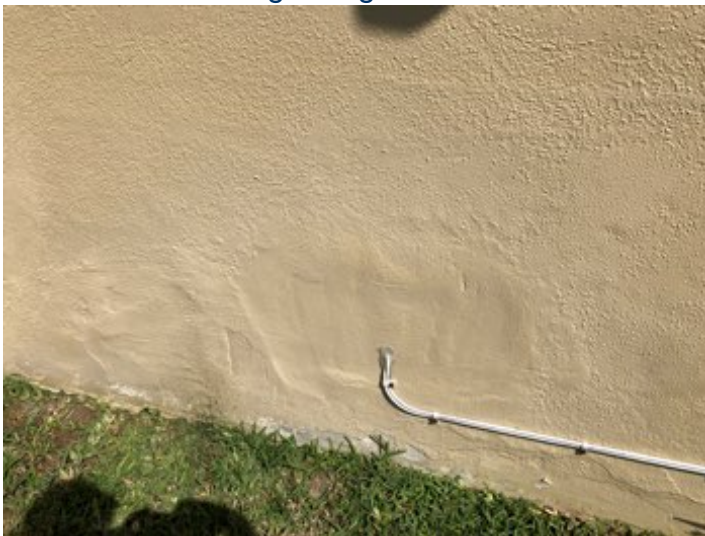
Previous Repair

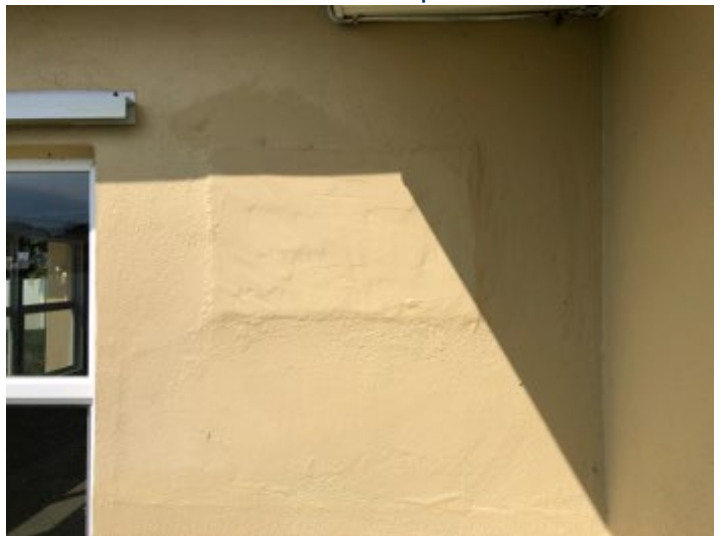
Old Window A/C Penetration

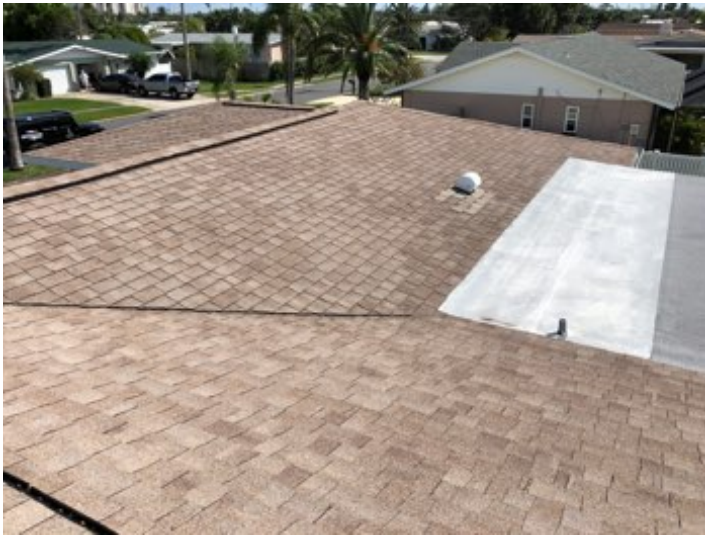
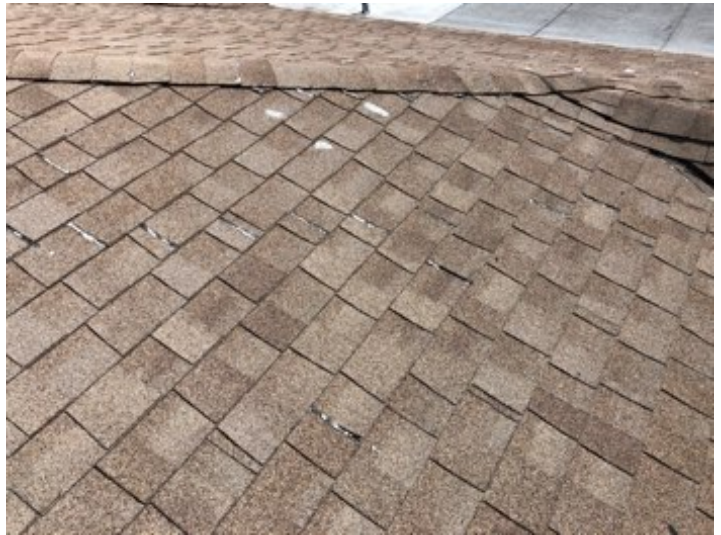
- Evidence of non-professional repairs done near chimney and vent areas. Recommend further evaluation by certified roofing contractor.

Caulking or Silicon from Previous Repair

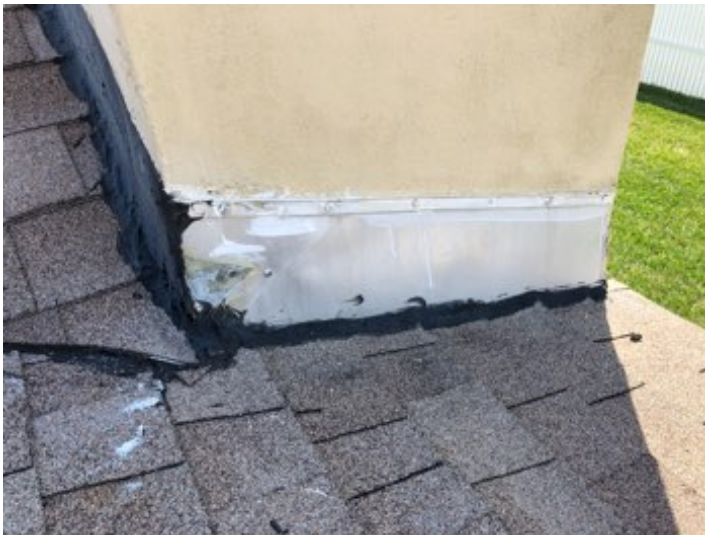
Tar From Previous Repair

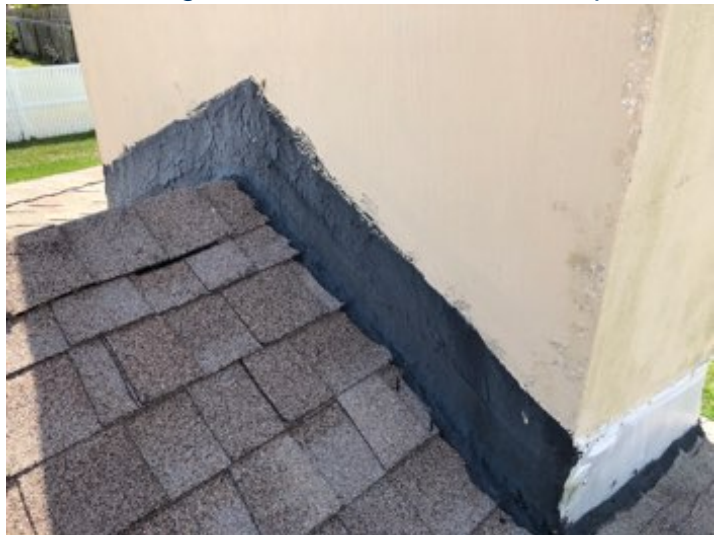
Heavy Tar Where Flashing Should Be

- Improper installation using sealant instead of flashing. Recommend continued monitoring for water intrusion.
- Improper counter flashing near chimney. Tar and/or silicon sealant is bubbling near chimney area. Step flashing and counter flashing is recommended at chimney crickets per InterNACHI SOP.

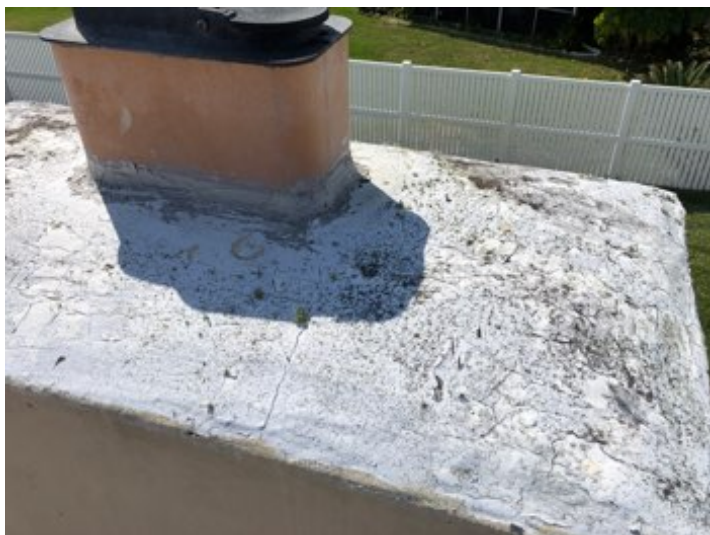
Recommend Sealing or Masonary Repair

- Flaking, spalling or loose bricks observed on chimney.

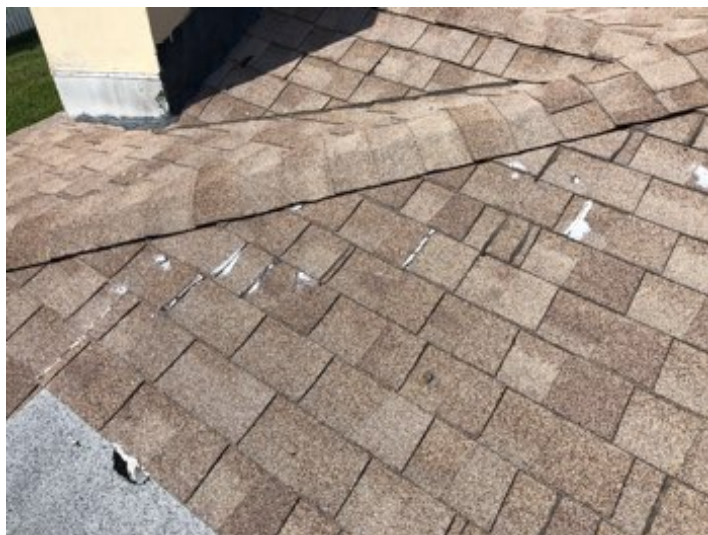
Previous Shingle Repairs w/ Caulk or Sealant

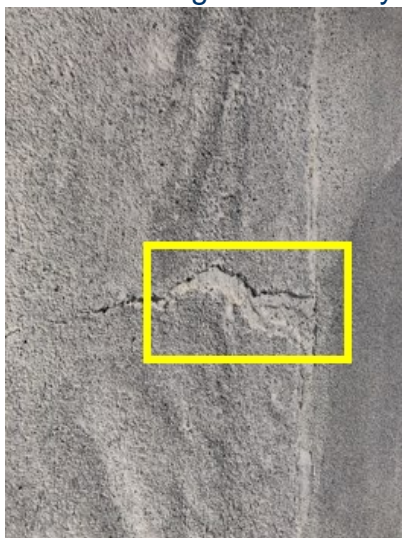
Crack in Flat Roof Area

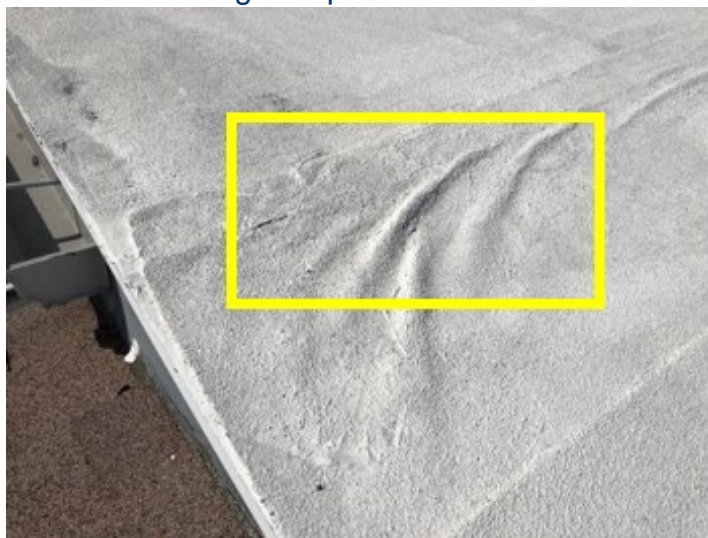
Recommend Further Evaluation

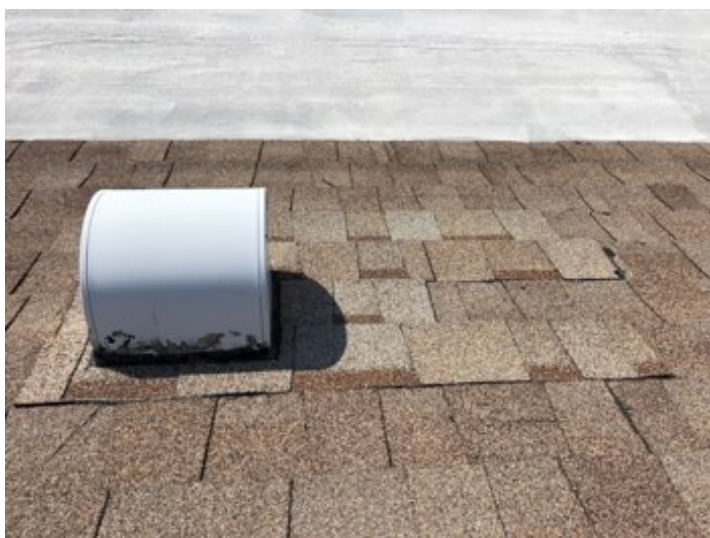
Previous Repair

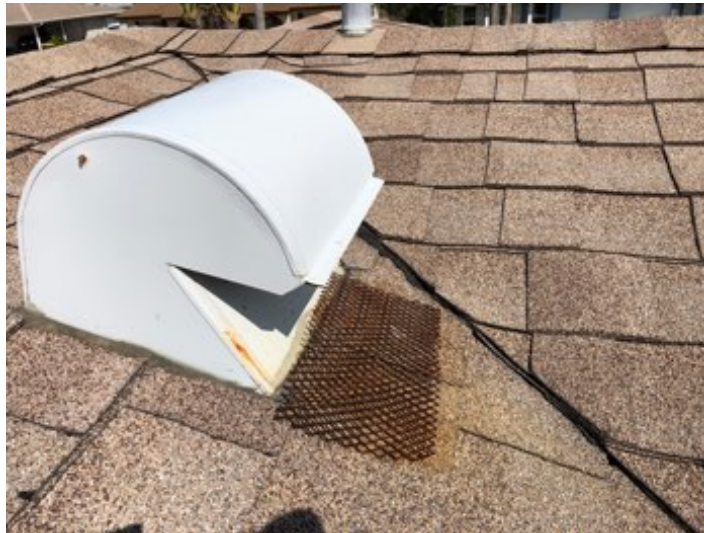
- Vent cap mesh is detached. Recommend evaluation and repair by qualified professional.

Rodent Mesh Detached

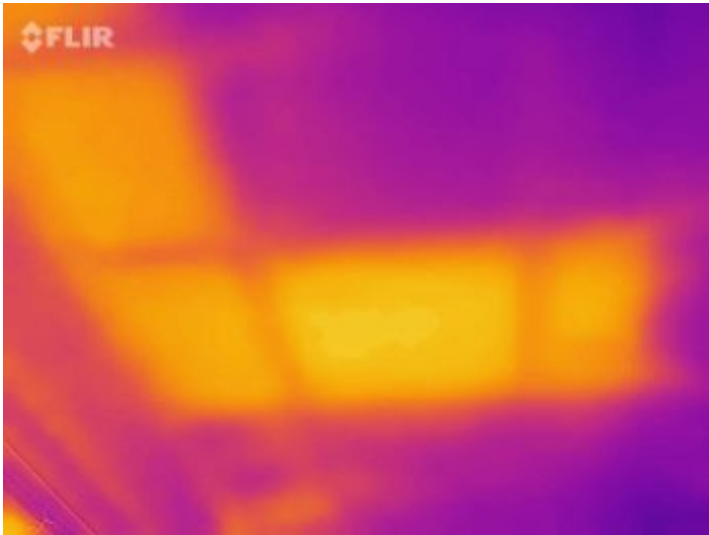
- No insulation over drywall ceilings in master bedroom and to the left side of fireplace.

Master Bedroom Missing Insulation

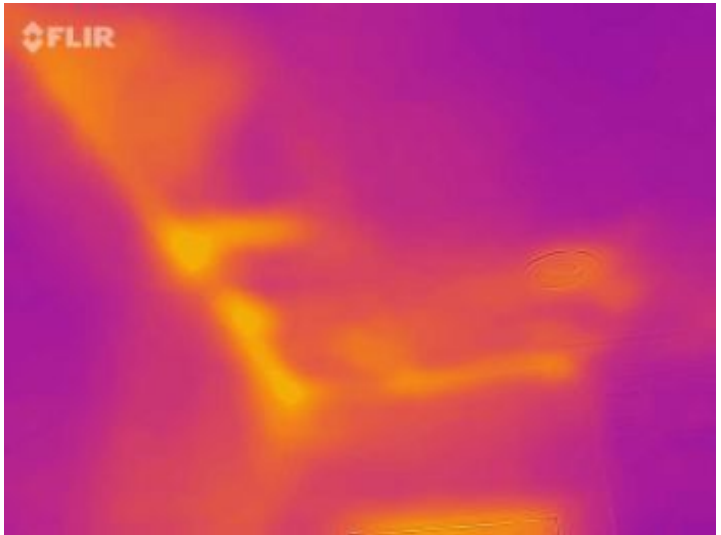
Family Room Missing Insulation

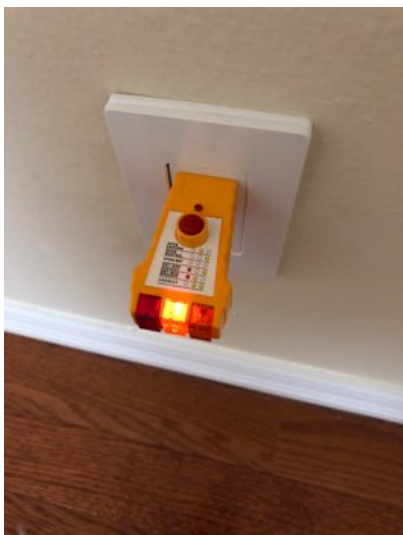
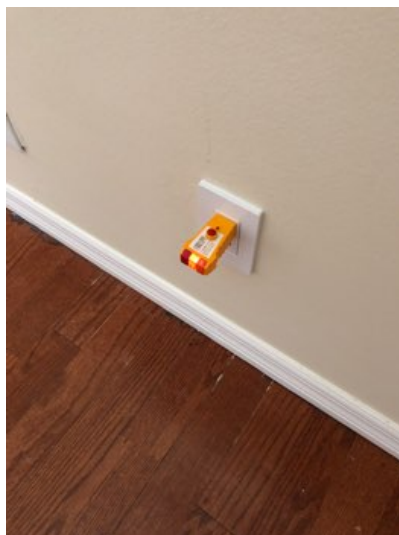
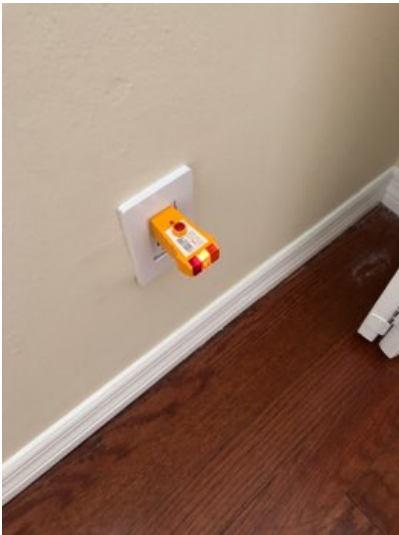
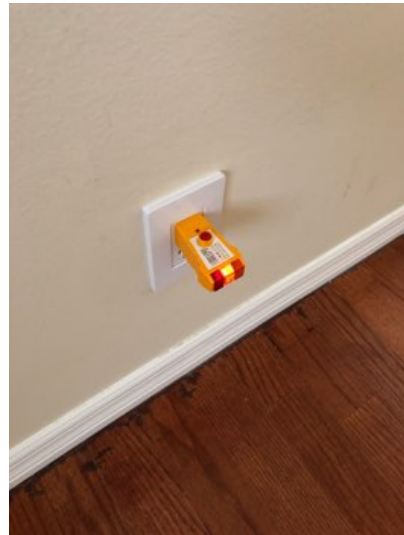
- All receptacles in the west bedroom had open ground. Recommend further evaluation by a licensed electrical contractor.

Open Ground - West Bedroom

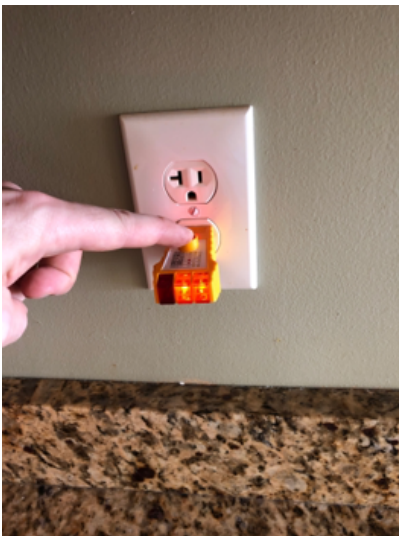
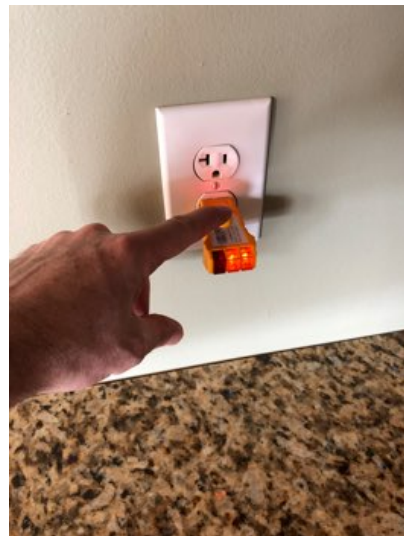
- Outlets in kitchen did not respond to a GFCI test. Evaluation by electrician recommended.

Non-GFI Protected Kitchen Outlet

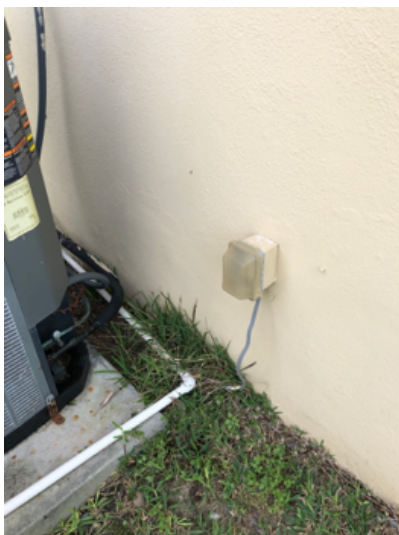
- Romex should be enclosed in conduit or pipe. Recommend repair by licensed electrician.

Outdoor Outlet Improperly Installed

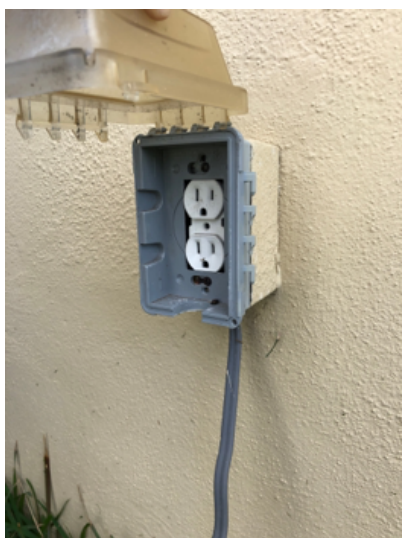
- Exterior receptacle near A/C compressor on north side not GFCI protected.

No GFI

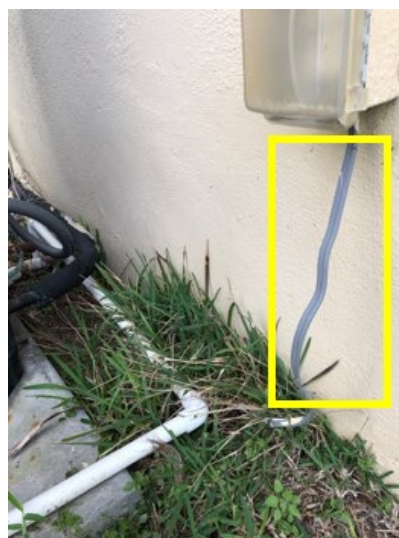
Wire Should Be in Pipe

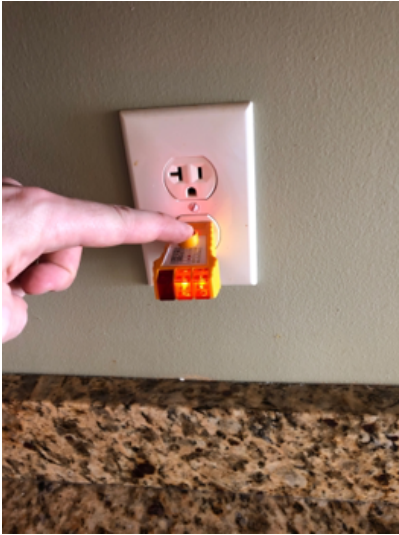
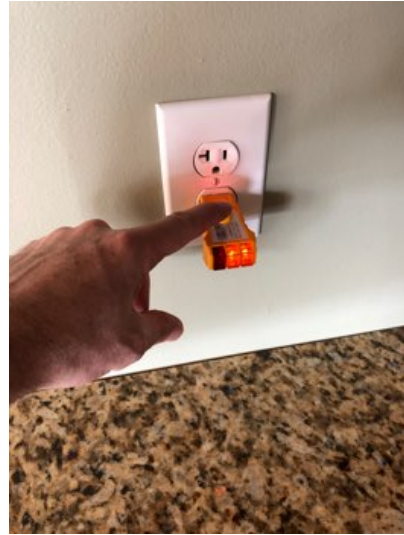
Non-GFI Protected Kitchen Outlet

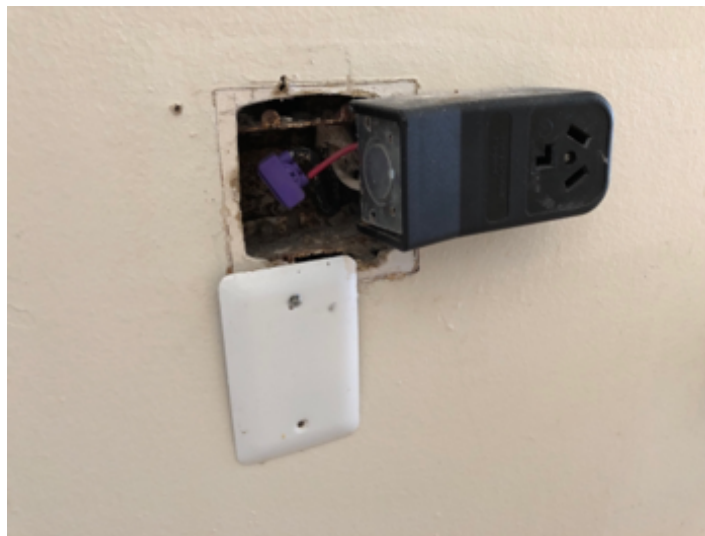
- The garage 240 volt outlet is missing a cover plate, which is a shock hazard. Recommend repair by an electrician.

Exposed 240 Box

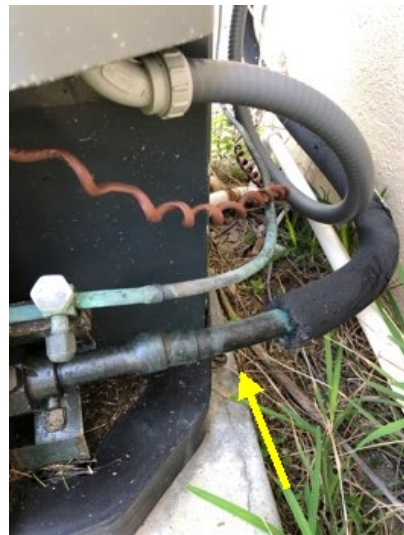
Refrigerant Line Missing Insulation

- Recommend adding insulation at A/C refrigerant lines to prevent condensation and energy loss.

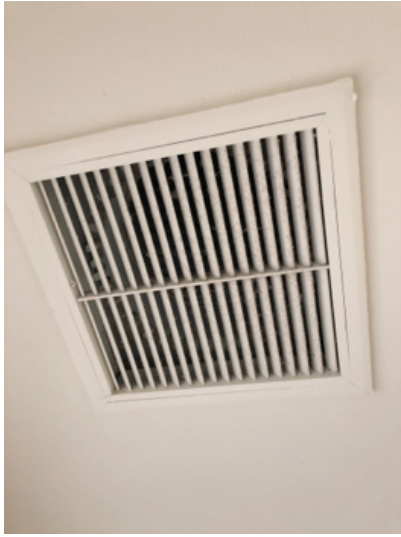
- AC filters are located in a filter grill in the entry hallway and bedrooms hallway. Missing filter in

bedroom return. Recommend servicing of A/C to check for debris on evaporator due to missing filter.

Missing Filter

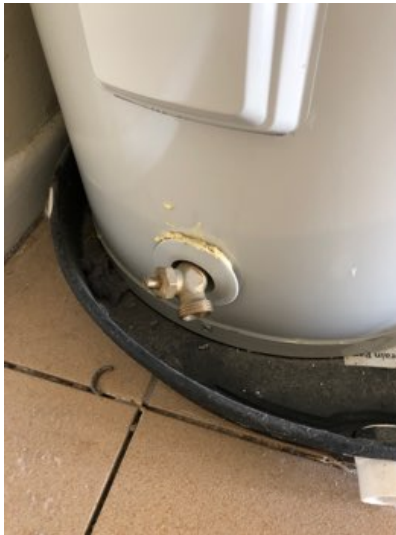
- The extension at the water heater relief valve is missing. This is a potential scalding concern as water can discharge improperly. Recommend installing the proper type of relief extension to discharge within 6 to 8" from the floor.

TPR Not Properly Terminated

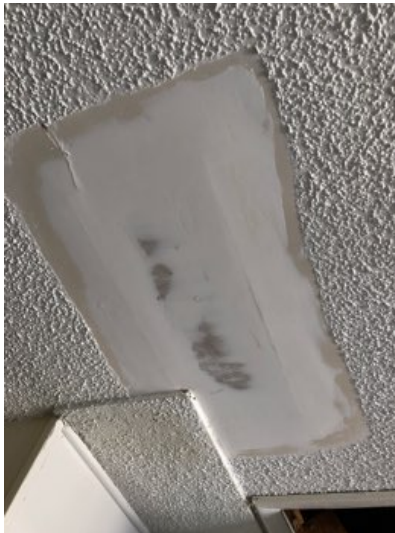
- Firewall protection noted between garage and living space. Previous repair noted.

Previous Ceiling Repair Garage
